**Re: Cenveo Corporation's First Supplemental Response to U.S. EPA's
104(e) Request for the Portland Harbor Superfund Site**

**REPORT OF
PHASE I ENVIRONMENTAL SITE ASSESSMENT UPDATE
OF**

ATC Associates Inc. (ATC) has performed a Phase I Environmental Site Assessment Update (ESA Update) of the Graphic Arts Center building (the Site) located at 2000 NW Wilson Avenue in Portland, Oregon. Darin Wirth, Project Manager of ATC, conducted the site reconnaissance on April 12, 2000. The ESA Update included environmental regulatory database review, interviews, Site observations, and report preparation. The scope of the ESA Update was in general accordance with the ASTM Standard Practice E 1527-97. This report includes ATC's findings, conclusions, recommendations and supporting documentation.

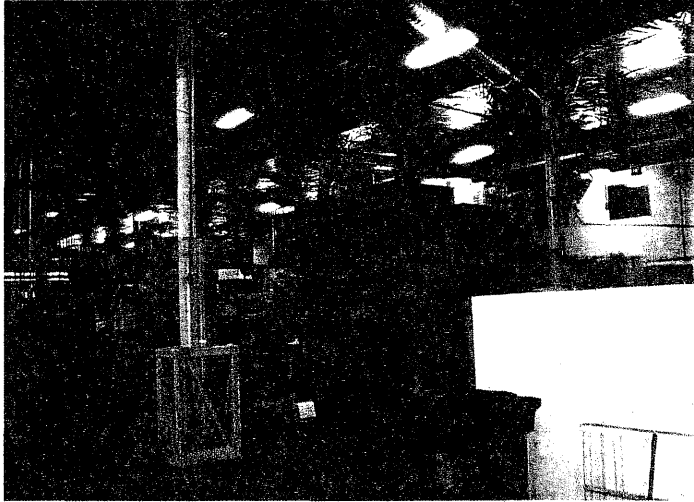
The Hazard	<p>Pallet storage contributes a large amount of fuel to a fire. A fire involving pallet storage will produce large amounts of heat and smoke, causing extensive damage to the building and contents. The heat release will fuse more sprinkler heads at the ceiling than the system was designed for and overtax the water supply. The sprinklers would not be able to function properly and the fire could grow out of control.</p>

<p>Plastic Pallets</p>
Status	There are no current plans to complete the recommendation.

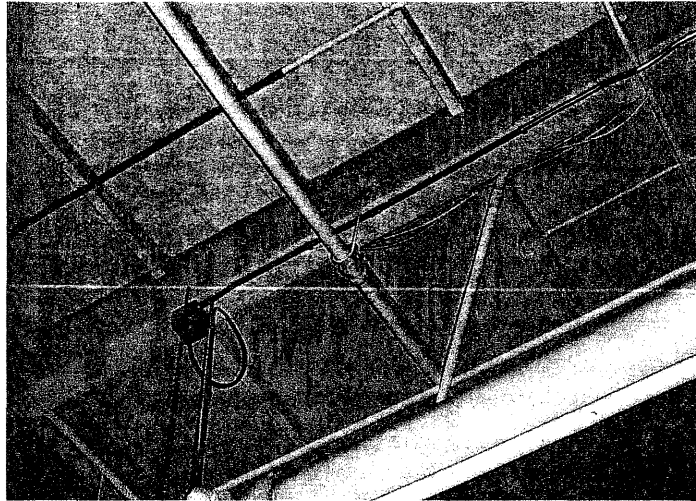
Without proper bracing, automatic sprinkler pipes can shake violently during a seismic event. If the seismic event is of great magnitude, the pipes can break resulting in water damage to goods and leave the manufacturing facility without protection from a fire.

U-Hook Sprinkler Bracing

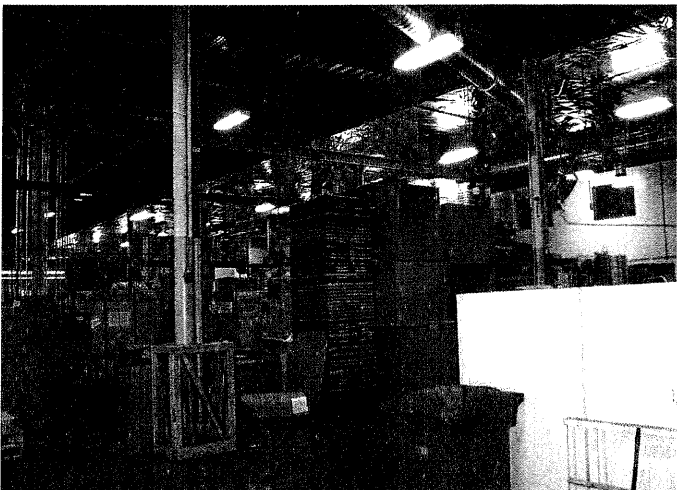
The Hazard	<p>Pallet storage contributes a large amount of fuel to a fire. A fire involving pallet storage will produce large amounts of heat and smoke, causing extensive damage to the building and contents. The heat release will fuse more sprinkler heads at the ceiling than the system was designed for and overtax the water supply. The sprinklers would not be able to function properly and the fire could grow out of control. Inadequate storage arrangement and protection of plastic pallets present a major fire hazard, with the potential of causing substantial damage to property and interruption of business at this Cenveo location.</p>

Plastic Pallets
Status	<p>Mr. Smith suggested that storing pallets in trailers outside the building might be possible and would look into this alternative.</p>
04-07-001	Improve flammable liquids handling.
The Hazard	<p>Flammable liquids present an extreme fire hazard. If released, the vapors are easily ignited by hot surfaces, and burn intensely. Because they are liquid the fire will easily spread. If the fire involves the combustible roof, little can be done to prevent major damage to both building and contents and result in months of lost business operations. A fire like this would compromise the sprinkler systems performance, since it is not designed to deliver enough water to control a fire involving flammable liquids without additional precautions. This hazard will be reduced by proper handling and storage of all flammable liquids as outlined.</p>

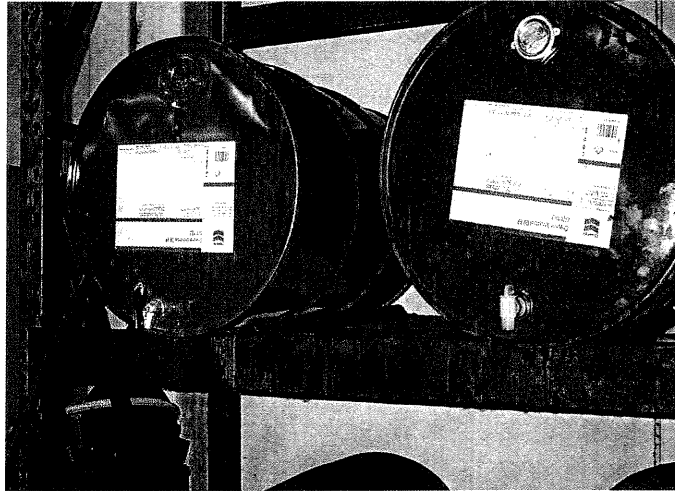
**Right; drum with plastic dispenser without self closing mechanism.
Left; the recommended dispenser.**

Plastic dispensers currently used on 55 gal. oil drums should be replaced by FM Approved self closing metal dispensers. Also, provide safety bungs for oil drums arranged for on-side dispensing.

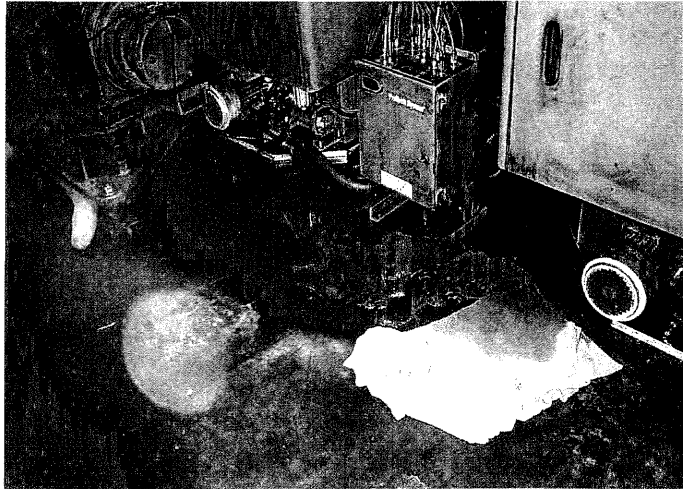
The Hazard	<p>A spark originating in the press motor could catch the oily deposits around the motor casing on fire. Due to this added fuel a fire could grow larger then anticipated requiring a greater number of sprinkler heads to control the fire and causing damage to the press and surrounding room. In addition, non-thermal damage (water) from the sprinklers could destroy paper storage and create additional clean-up.</p> <div data-bbox="682 966 1360 1453">

</div> <p>Oily deposits under M600 press.</p>
Technical Detail	<p>During this visit it was noted that oily fluids had been leaking under the press and accumulated on the floor.</p>

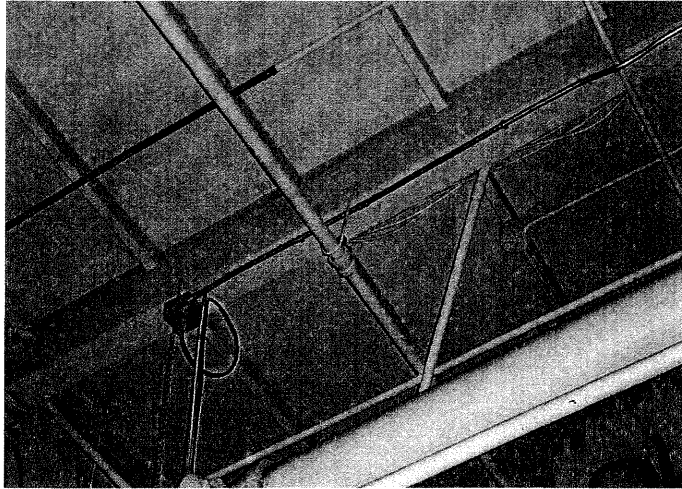
<p>U-Hook sprinkler bracing.</p>
Technical Detail	Seismic protection for the automatic sprinkler systems should be upgraded in the following manner:

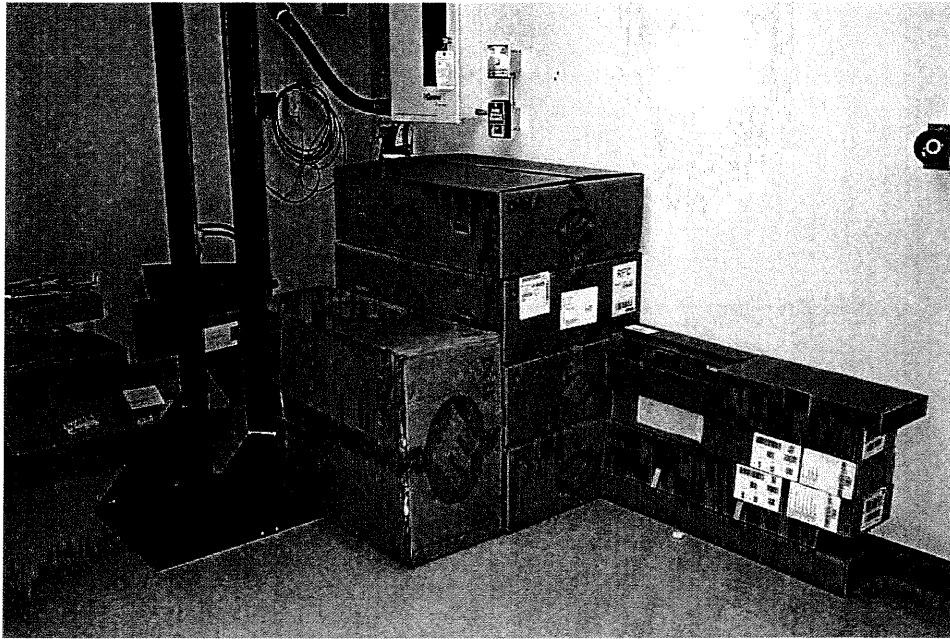
Combustible storage in Computer Room.

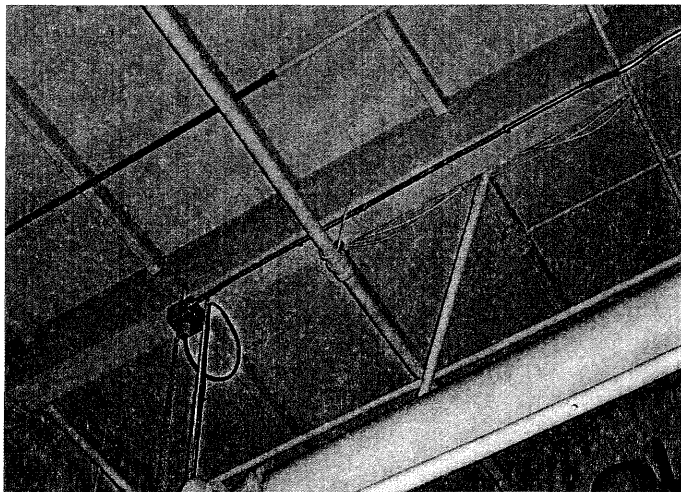
<p>U-Hook sprinkler bracing.</p>
Technical Detail	Seismic protection for the automatic sprinkler systems should be upgraded in the following manner:

98-07-006	<p>Upgrade seismic protection of sprinkler systems.</p> <p>Seismic protection for the automatic sprinkler systems should be upgraded in the following manner:</p> <ul style="list-style-type: none"> • Longitudinal and Lateral earthquake sway braces. • Standard U-hooks and C-Clamps should be restrained. • Suspended ceilings. • Pipe drops.
The Hazard	<p>Without proper bracing, automatic sprinkler pipes can shake violently during a seismic event. If the seismic event is of great magnitude, the pipes can break resulting in water damage to goods and leave the manufacturing facility without protection from a fire.</p>

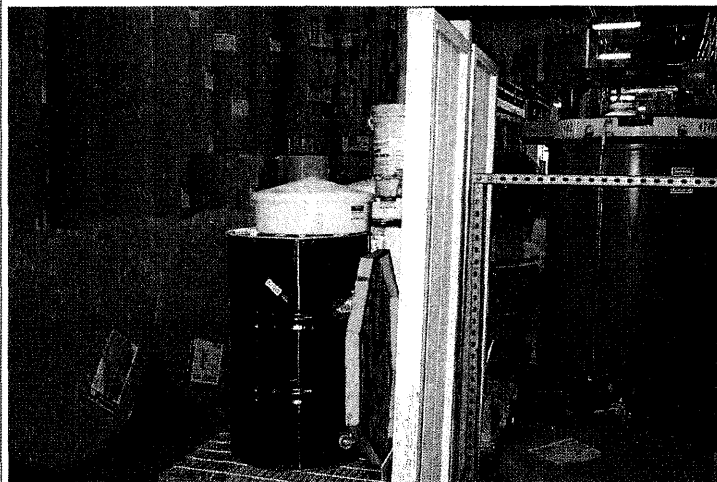
The waste drums of solvent and oil could easily be upset while handling the drums or knocked over when handling the nearby roll paper. On hot days, the temperature inside the building could be near or above the flash point of the waste solvent. Since a full drum of solvent could create a spill 35 feet in diameter, the spill could flow into the roll paper storage area. The flammable vapors from the spill could be easily ignited by the many ignition sources on the print floor. Once ignited, a large portion of the roll paper storage could be rapidly involved in the fire. This fire would likely be well beyond the ability of the sprinkler system to control, or even slow down. Once the fire involves the roof, it could spread from through out all buildings resulting in the loss of the facility.

Waste solvent stored next to Paper Storage.

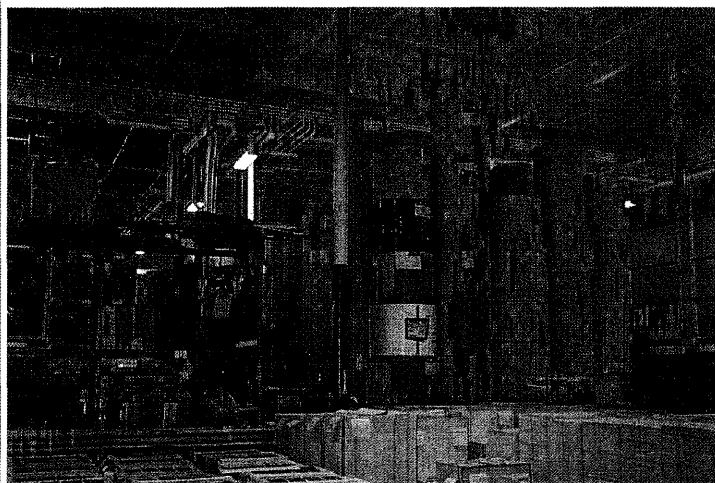
The Hazard	Paper burns so easily that many people use it for kindling. Roll paper storage presents an especially hazardous arrangement, since it burns fast and furious. Fire spreading up the side of a paper column quickly burns through the outer layer. The roll of paper can then unwind or peel, which rapidly increases the amount of burning surfaces. This results in a very hot fire that spreads rapidly to adjacent rolls and combustibles. The efficiency of the sprinklers are reduced in a roll paper fire because as the outer layers are wet by the sprinklers they slough off exposing more dry paper to the fire. Therefore, it is critical to limit the storage heights of the roll paper so that the sprinklers can deliver enough water to control the fire and prevent it from spreading though out the facility.
-------------------	--

**Roll Paper Storage up to 21 feet.**

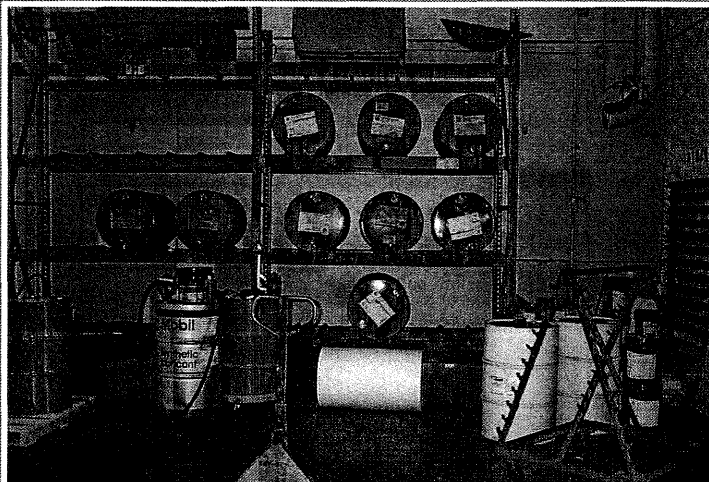
Plastic or no containment under oil drums

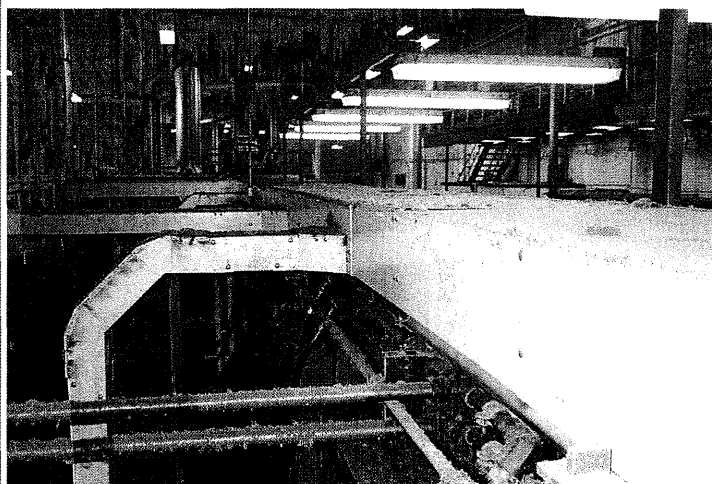
Paper dust is much easier to ignite than paper in a sheet form. Electrical faults, overheated components, and sparks from static or friction all could provide the necessary energy to ignite the dust. When dust deposits are heavy enough, a fire involving the dust tends to "flash" across the dusty surface. Rapidly spreading fires involving large areas of dust could easily out run the sprinkler system and ignite nearby combustibles. The sprinkler system is not designed to control multiple fires over such a large area, and could be overwhelmed. This would allow the fires to grow and spread to the nearby combustible ink, oil, and paper storage. At this point, it is likely that the fire would continue to grow and spread from building to building resulting in the loss of the entire facility.

Dust accumulation on the wireways above the M600

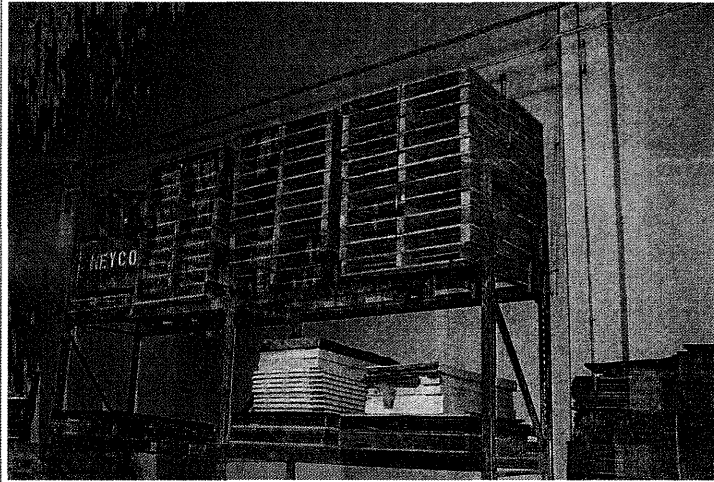
**Pallets stored in racks****Technical Detail**

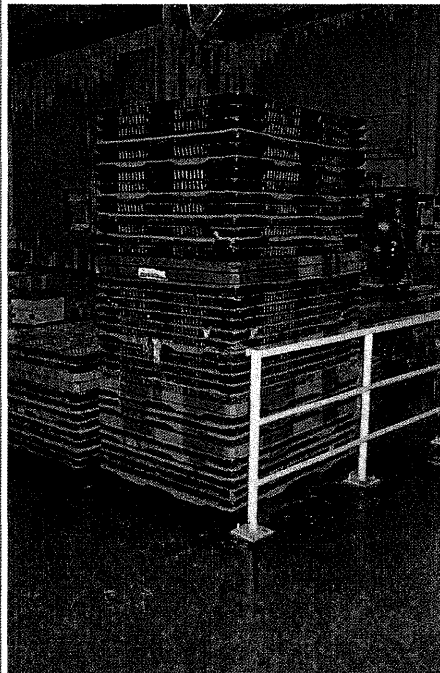
**Plastic pallet storage exceeding 3 feet****Technical Detail**

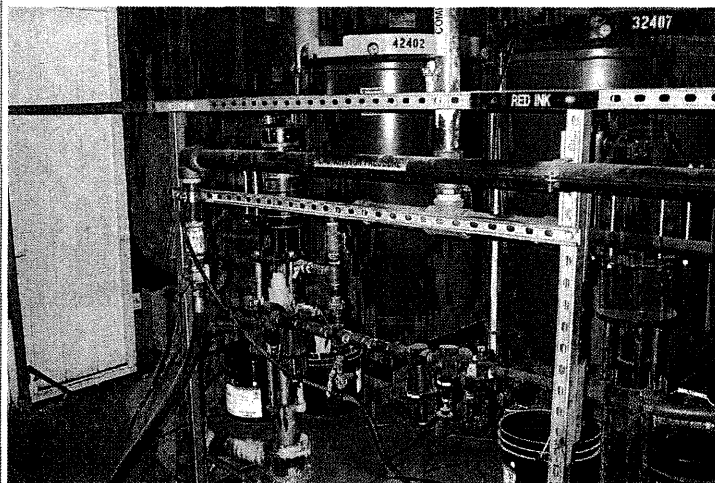
At the bulk ink dispensing area, ink is dispensed from 2,800-pound totes into plastic buckets. These totes contain several hundred gallons of ink with a flash point greater than 240 F. While this ink is difficult to ignite, it will burn furiously if involved in a fire. A fire fueled with the ink contained in the totes would present a very challenging fire that would be difficult to control. As the ink is heated by the fire, the viscosity decreases and it could flow forming a large pool and involve the nearby roll paper storage. It is likely that the sprinkler would control the fire and limit fire damage to the dispensing area, M600 press and roll paper storage; however, large amounts of thick black oily smoke would fill the facility and could damage products and raw materials.

**Bulk ink dispensing.****Part A.****Replace the flexible hoses on the bulk totes with non-combustible hoses.**

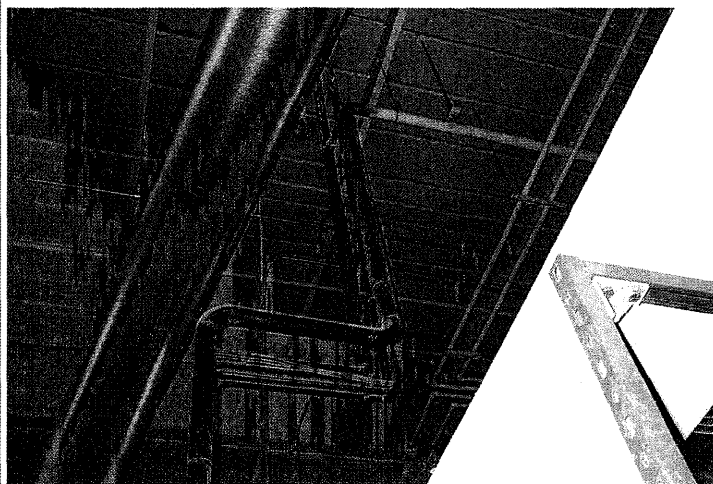
This facility is located in seismic zone 250 and is subject to severe shaking during an earthquake. An earthquake will introduce motion between equipment and the building. This movement can stress connections and result in small leaks or even a major break in the gas supply line. Once released, natural gas is easily ignited by the many ignition sources in the building. Hot surfaces, damaged electrical wiring, or even the spark from a light switch could ignite the gas. Once ignited, the flame from the leaking gas pipe could ignite any nearby combustibles. If the fire occurs near the wood roof, the roof could become involved in the fire. This would allow the fire to spread through out the buildings and could result in the destruction of the entire facility.

Lack of seismic bracing on 4 in gas line.

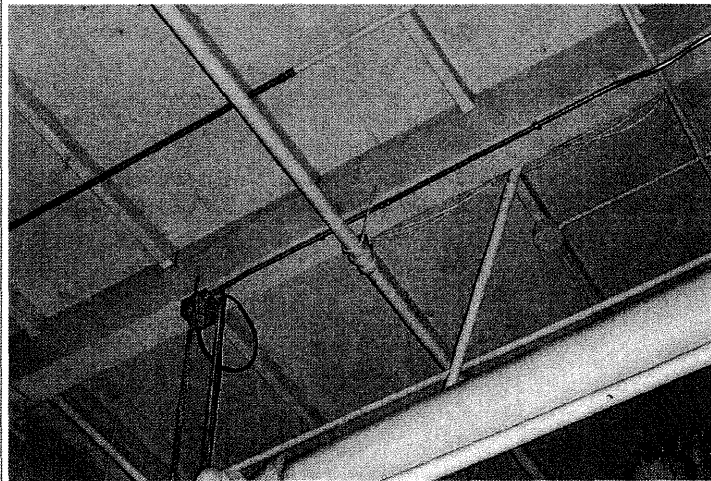
The Hazard	Without proper bracing, automatic sprinkler pipes can shake violently during a seismic event. If the seismic event is of great magnitude, the pipes can break resulting in water damage to goods and leave the manufacturing facility without protection from a fire.
-------------------	---

U-Hook sprinkler bracing.

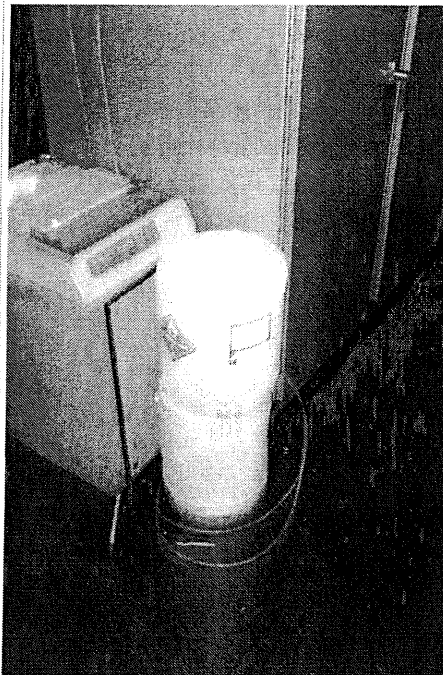
This liquid has a low flash point. A five gal. spill could cause a ten ft. diameter pool of liquid. If this liquid were to ignite, it could result in flames 30 ft. high.

Make-up ink buckets

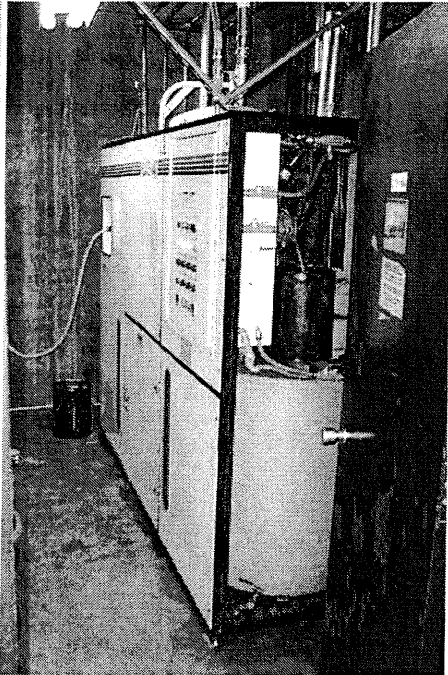
The Hazard	<p>The distillation unit heats Cyrel OptiSol, which has a flash point of 154°F, above its boiling point (around 350°F), and then condenses the clean liquid. Any upset in this process could cause an explosion, which would blow into the plate making area. Any leak would be able to catch fire and spread under the door to the plate making area.</p>

<p>Solvent Waste Recovery Unit</p>
Status	<p>Ms. Melissa Otis said that she would see if this could be done.</p>

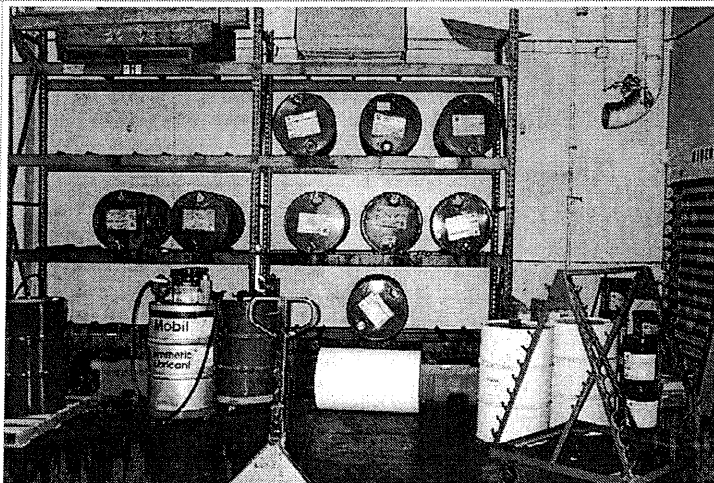
Plastic containment under oil drums

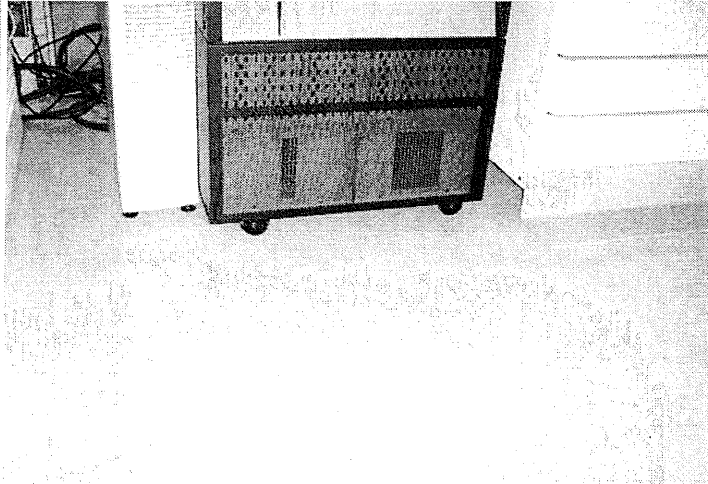
This equipment is critical to business operations, and if damaged may interrupt business continuity. Due to their high center of gravity, electronic cabinets and racks are subjected to seismic forces that could result in toppling. Usually, bolting equipment to the floor is sufficient to prevent damage.

**Mainframe Securement****Status**

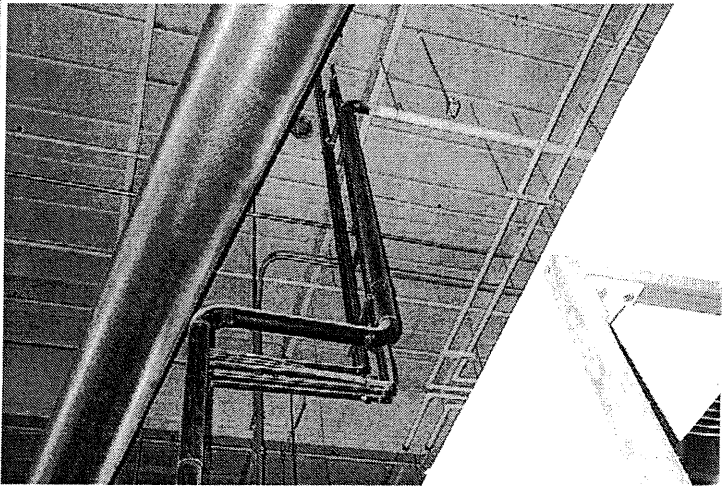
The bulk of damage from earthquakes is often related to fires following the earthquake. This is what destroyed San Francisco after the 1906 quake. Most frequently, the combustibles that are ignited are flammable gases. A seismic gas shutoff valve is present to limit this exposure, but the gas that would remain in the pipe following a shutoff is sufficient to still cause a fire. Bracing and flexibility will reduce the likelihood of damage in the most likely location of gas pipe breaks.

Lack of seismic bracing on a 4 in. gas line.

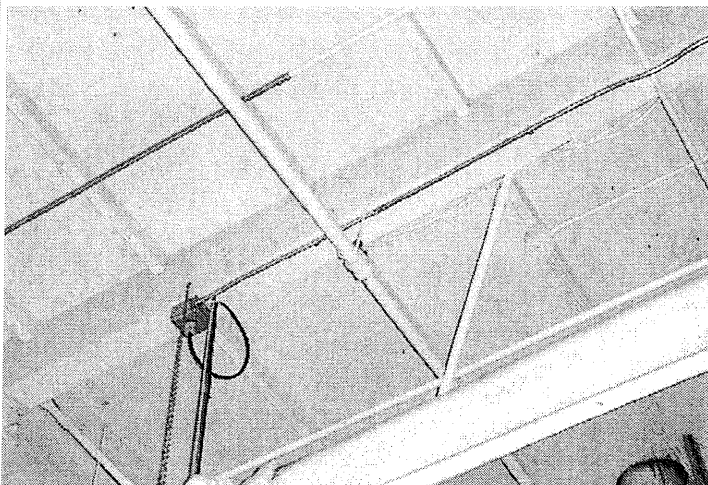
**U-Hook sprinkler bracing.****Technical Detail**

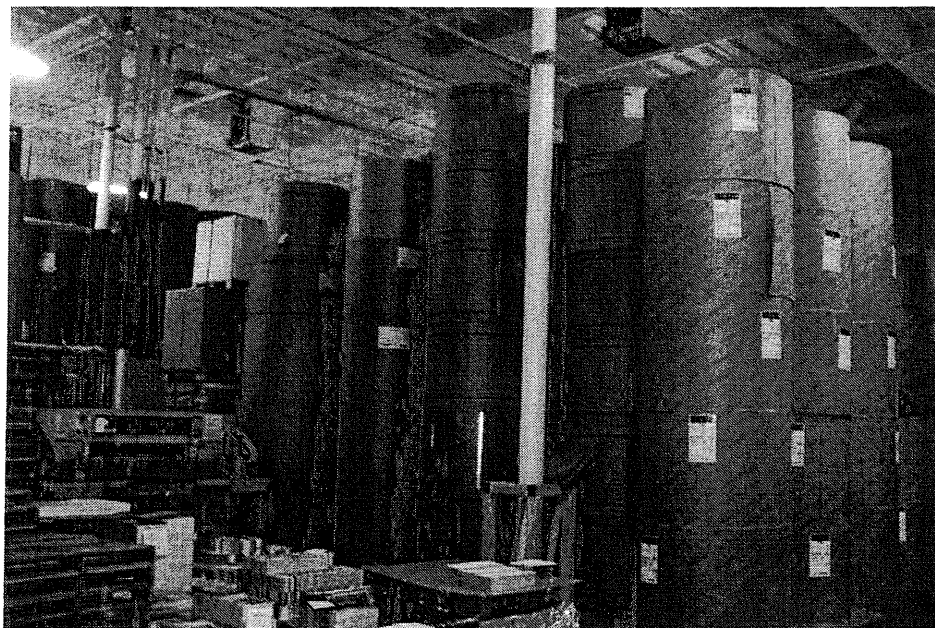
Lowered Roll Paper Storage
